NASA Contractor Report 172344

Flight Service Evaluation of Kevlar-49 Epoxy Composite Panels in Wide-bodied Commercial Transport Aircraft

Tenth and Final Annual Flight Service Report

LOCKHEED-CALIFORNIA COMPANY
BURBANK, CALIFORNIA

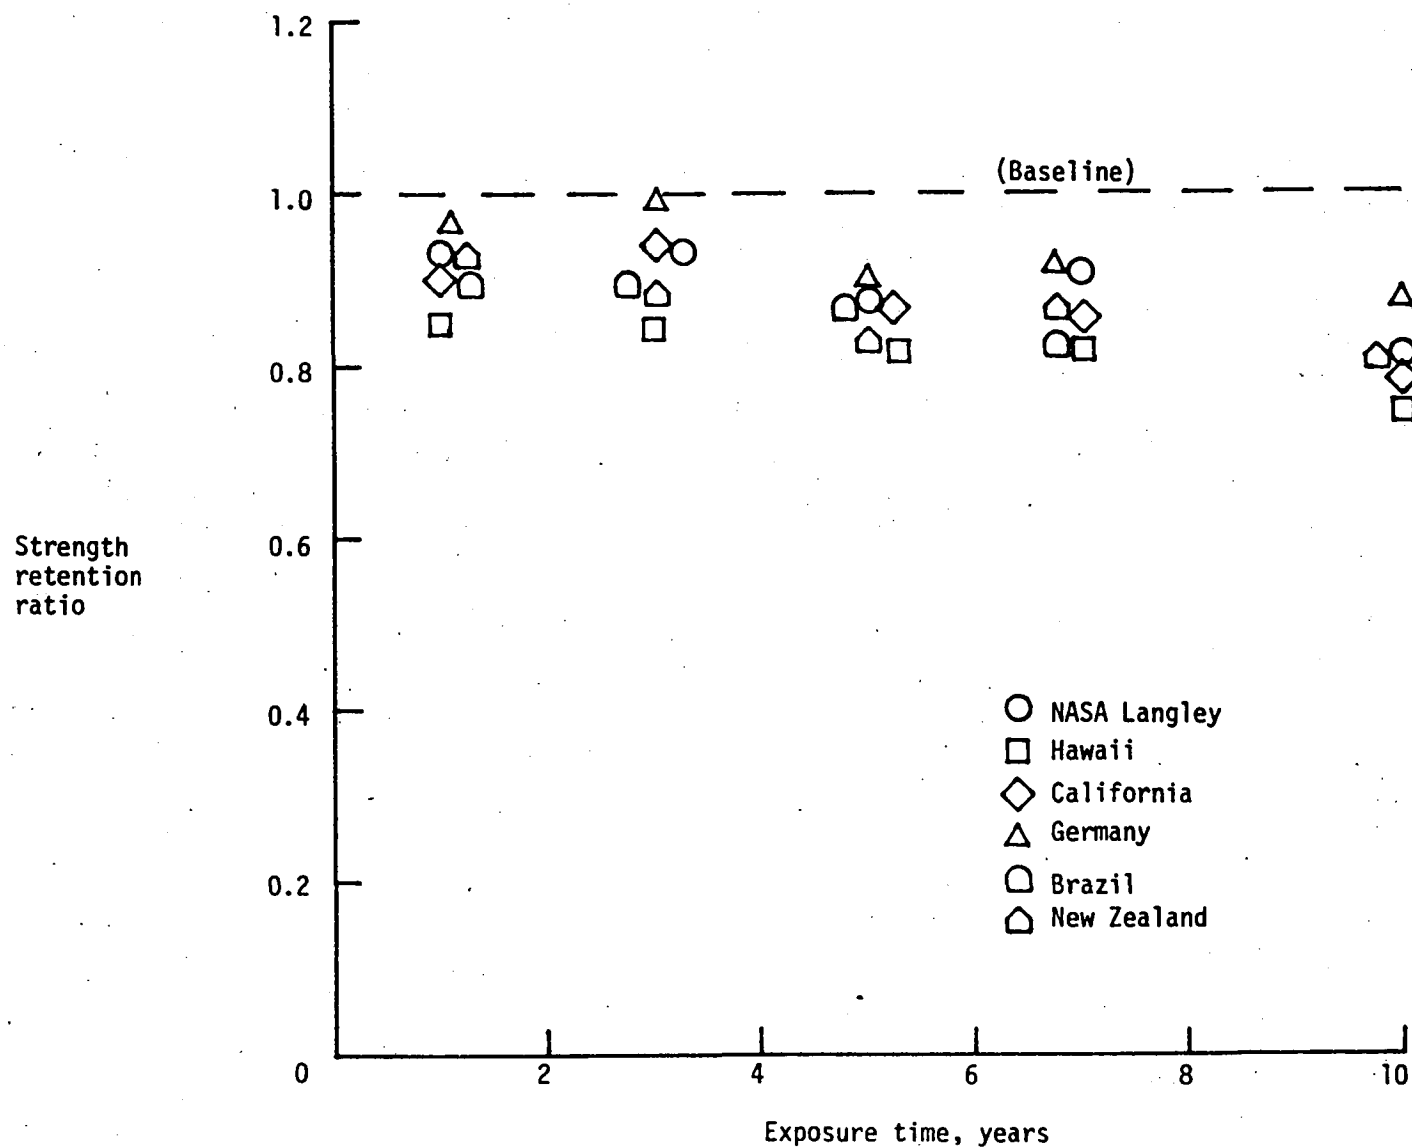
Figure 4. RT Flexure Strength Retention of Kevlar/F-155 After Outdoor Ground-Based Exposure.

Tables 2, 3, and 4 show the flexure, short beam interlaminar shear, and compression strengths, respectively, for specimens exposed for ten years at the locations indicated. The specimens from the Brazil exposure rack will not be tested until the summer of 1984. Figures 4 through 9 show average strength retention ratios for specimens tested after one, three, five, seven, and ten years of exposure at the six exposure locations indicated on the figures. The strength retention ratio is a comparison of the average specimen strength after exposure with the average baseline (no exposure) strength for the material system. The Kevlar/F-155 flexure specimens (figure 4) showed an average strength reduction of ten percent after one year of exposure and an average strength reduction of about 20 percent after ten years of exposure. The Germany exposure appears to be the least severe, whereas, the Hawaii exposure appears to be the most degrading on the flexure strength of Kevlar 49/F-155. The Kevlar/F-161 flexure specimens (figure 5) showed an average strength reduction of only about ten percent after ten years of exposure. The average flexural modulus (table 2) showed a reduction of about ten percent after ten years of exposure for both Kevlar material systems.

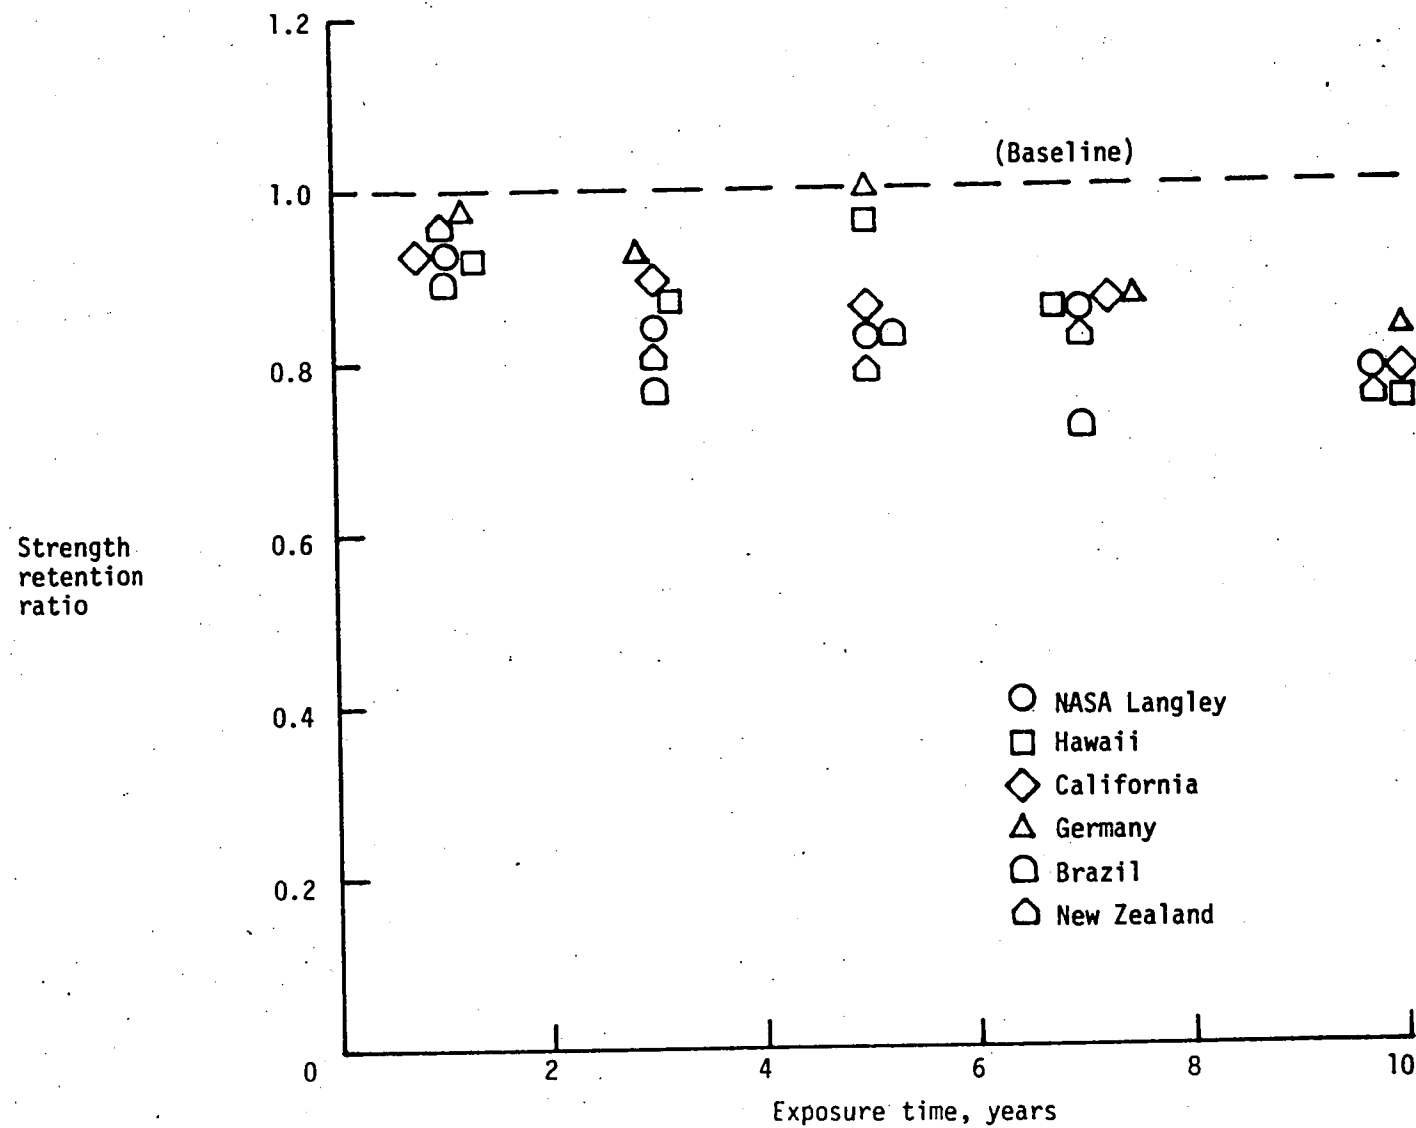
Figure 6. RT Short Beam Interlaminar Shear Strength Retention of Kevlar/F-155 After Outdoor Ground-Based Exposure.

The results for the SBS specimens are somewhat more erratic than the flexure results. The average SBS strength reduction after ten years of exposure is about 22 percent (figure 6) for the Kevlar/F-155 material system. The Germany environment is the least degrading; however, no consistent pattern is evident for the most degrading environment. Although the ten year results are not available for the Brazil exposure, it appears that the Brazil environment may be the most degrading based on the one, three, and seven year test results. The average SBS strength reduction after ten years of exposure is about ten percent (figure 7) for the Kevlar/F-161 material system. For some unknown reason, extreme data scatter is evident after five years of exposure. The SBS strengths range from a 13 percent increase for the Hawaii and Germany exposure to a 19 percent decrease for the California exposure.

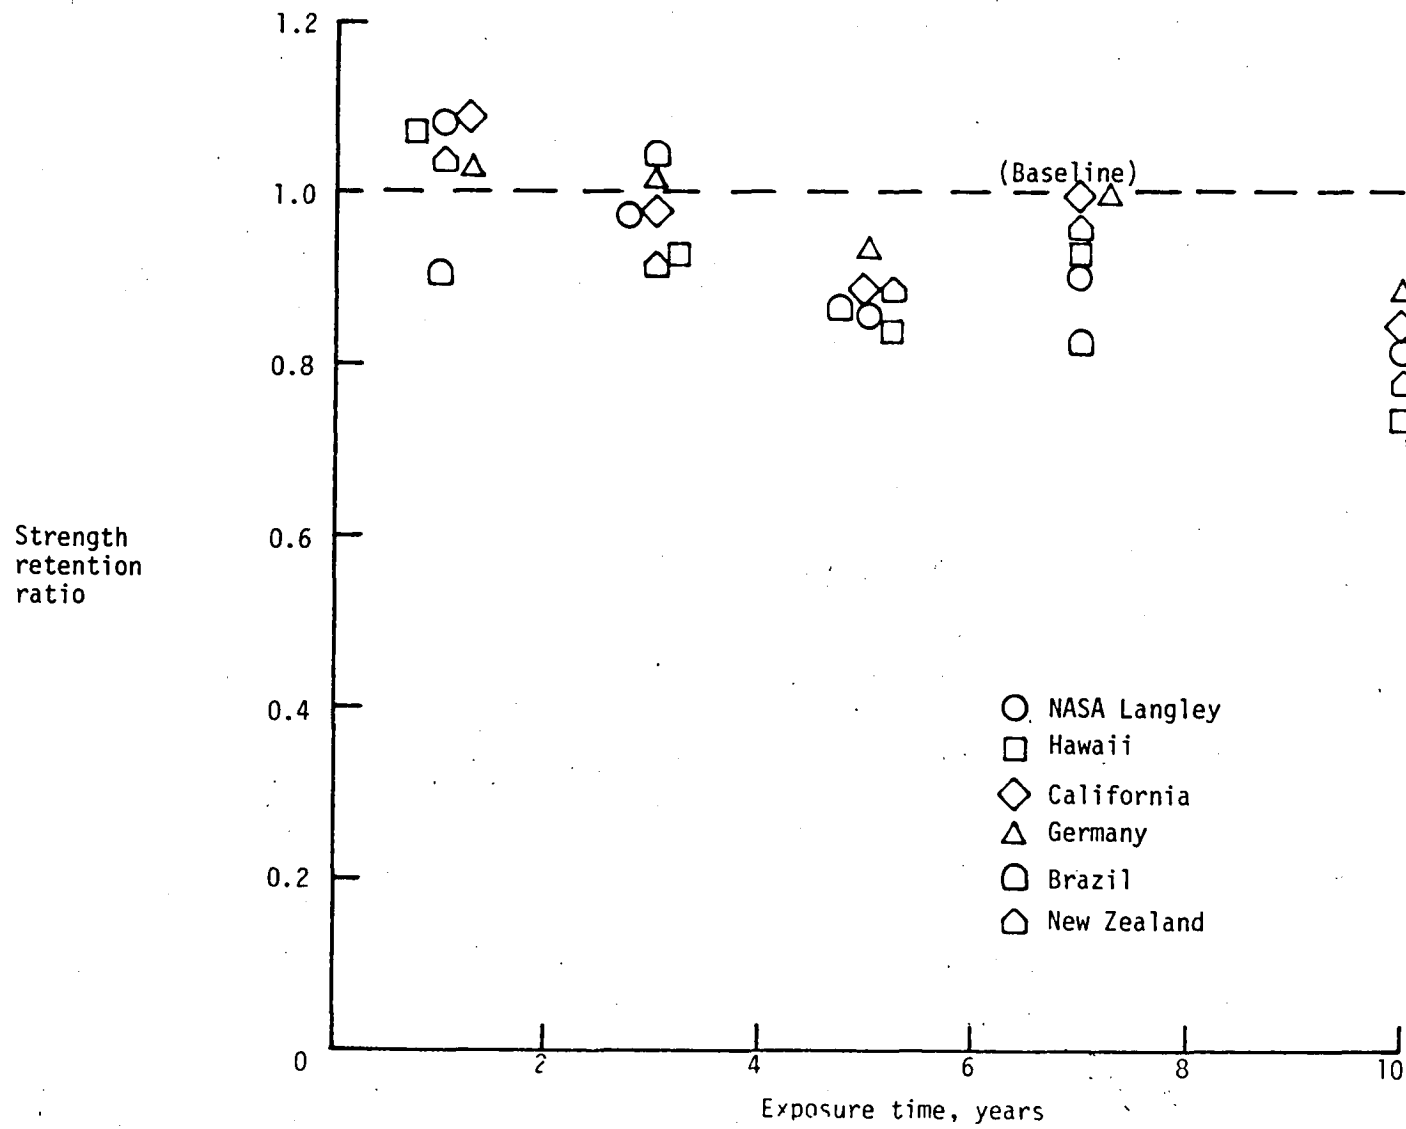
Figure 8. RT Compression Strength Retention of Kevlar/F-155 After Outdoor Ground-Based Exposure.

The compression strength data also indicates significant scatter in strength during the ten year exposure period. Except for the Brazil exposure, an average strength increase of about seven percent is shown for all exposure locations after one year of exposure for the Kevlar/F-155 material (figure 8). These results may indicate that additional tests should have been conducted to establish a more representative baseline strength. An average strength reduction of 19 percent is shown after ten years of exposure. The specimens exposed to the Hawaii environment showed a 27 percent average strength reduction after ten years of exposure. A similar data trend is shown for the Kevlar/F-161 compression strength (figure 9). An average strength reduction of 16 percent is shown after ten years of exposure. The specimens exposed to the Hawaii environment showed a 23 percent average strength reduction after ten years of exposure.
